Service Notification

Philips HID Aspiravision Independent driver

Date:	August 2014
From:	Philips Lighting BG LS&E
Subject:	Potential Philips HID Aspiravision independent driver miswiring in the application.
Description	<p>There is a possibility that the “hot” and “cold” lamp wiring between the plug&play GST 18i3 connector-equipped electronic driver and a separate independent luminaire is incorrect. This wrong polarization may compromise the performance of such a lighting system. See figure 1 and 2 below.</p> <div style="text-align: center;">

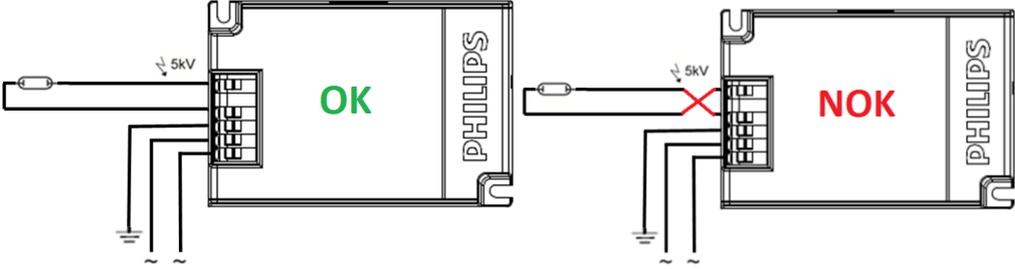
<p>Fig. 1: correct wiring Fig. 2: incorrect wiring</p> </div> <p>This configuration may be created inadvertently during individual lamp driver replacement.</p> <p>The wrong polarization does not require immediate remediation. However, it is highly recommended to carry out a wiring check during regular maintenance activities, e.g. if a driver needs to be replaced.</p> <p>This document describes step by step how to identify applicable installations and which necessary corrective actions need to be carried out to safeguard performance.</p>

If after driver replacement the reinforced wire is connected to the “cold” driver terminal then the wiring needs to be corrected. Correction has to be done by swapping the “hot” and “cold” lamp wires so that the “hot” wire is connected to the “hot” driver terminal. This will restore the correct polarization as shown in figure 1.

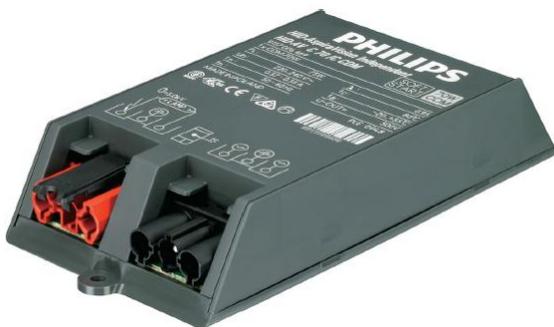
Fig. 3

-Wiring check applies to the following Philips drivers as shown in fig. 3.

Philips Aspiravision HID-AV C 35/C CDM with I0NC: 9137 006 469

Philips Aspiravision HID-AV C 70/C CDM with I0NC: 9137 006 479

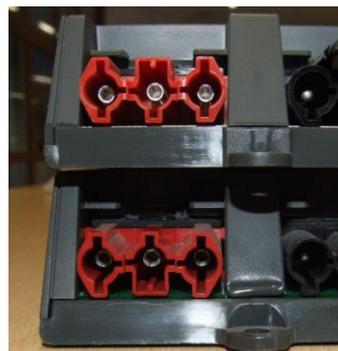
Fig. 6: Picture of variety I and variety II

Is the key position (notch in red square) in the middle lamp connector contact of the old driver identical to that of the new driver?

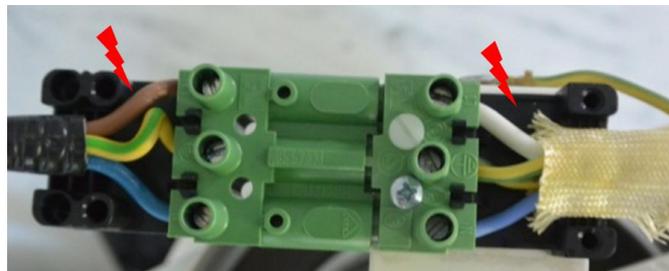
The “hot” lamp wire between driver and luminaire can be identified by opening up the cable connector and visual inspection of the insulation thickness. The “hot” lamp wire normally has a brown or white color and has a thicker reinforced insulation compared to the neutral and protective earth wire since it has to withstand high ignition voltage.

Fig. 7: Brown lamp wire = “hot”

Fig. 8: Brown and thicker white wire = “hot”

See fig. 7 and 8. The ‘hot’ lamp wire *always* has to be connected to the “hot” driver terminal.

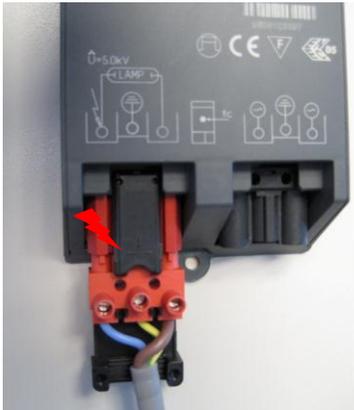
In figure 9 is shown an example of incorrect lamp - driver wiring. The reinforced “hot” lamp wire (brown) is connected to the “cold” driver terminal while the thinner “cold” wire (blue) is connected to the “hot” driver terminal.

Fig. 9: Example of incorrect lamp – driver wiring: reinforced brown wire is connected to the “cold” driver terminal
